CALSPAN ON-SITE AMBULANCE CRASH INVESTIGATION

SCI CASE NO.: CA12034

VEHICLE: 2005 FORD ECONOLINE 350 / MCCOY MILLER TYPE III AMBULANCE

CRASH DATE: JULY 2012

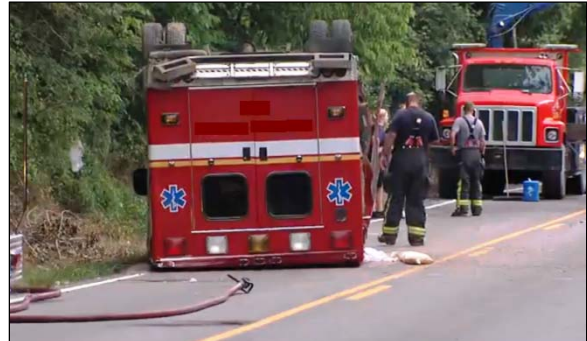
Figure 1: Involved ambulance at final rest (image obtained from a local news source).

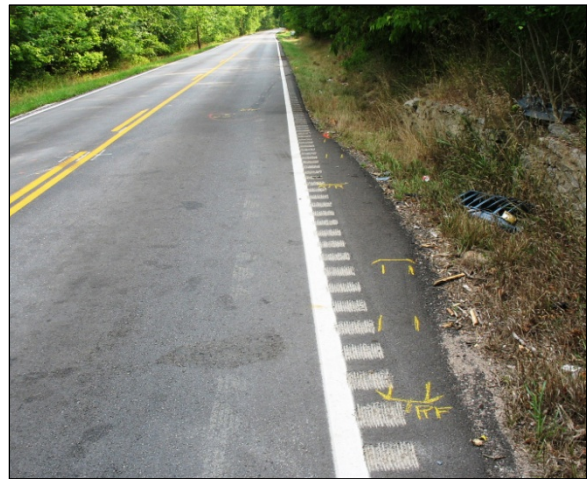
Figure 4: Roadside departure evidence associated with the ambulance's travel path.

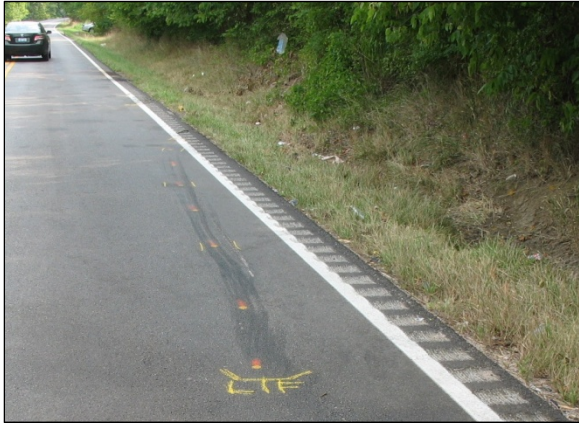
Figure 5: Left front tire mark evidence associated with the ambulance's travel path to Event 2.

As the Ford's right front bumper corner contacted the embankment, the right front axle position engaged the depression of the ditch and induced a sharp clockwise (CW) rotation. This was evidenced by the left front tire mark of the ambulance, which doglegged sharply right over the west white lane line and departed the west road edge perpendicular to the point of impact (**Figure 5**). The ambulance rotated CW and surpassed 90 degrees at 18 m (59 ft) south of the point of initial impact with the Jeep. An instability was created by the lateral drag force on

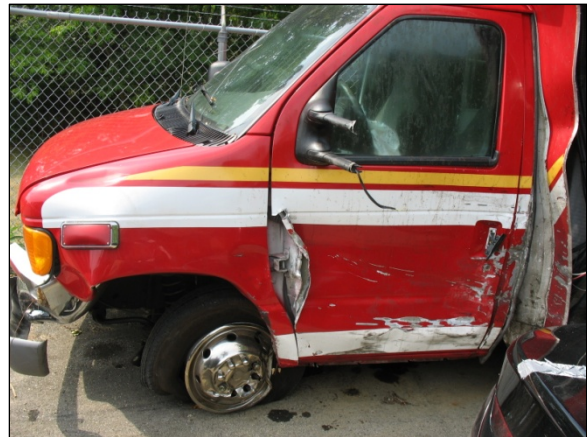
Figure 8: Left plane damage to the ambulance's cab (note front axle displacement).

axle position, which shortened the left wheelbase by 14 cm (5.5 in). Damage on the left plane continued from the left front fender onto the left front door of the cab, including minor body deformation with longitudinal abrasions. There was also black rubber transfer on the Ford's left front fender, attributable to the Jeep's left front tire. The forward aspect of the left front door was peeled rearward by the impact, exposing the door hinges. Direct contact damage extended onto the patient compartment module, with major deflection and full-height structural separation of the entire left front corner of the module. Within this damage pattern was minor lateral deformation. Across the 300 cm (118 in) Field-L, lateral crush included: C1 = 1 cm (0.5 in), C2 = 2 cm (1 in), C3 = 5 cm (2 in), C4 = 8 cm (3 in), C5 = 4 cm (1.5 in), and C6 = 2 cm (1 in). Maximum crush was located on the left front door of the ambulance near the handle (C4 location). No WinSMASH calculations could be performed for this (or any of the following) impact events because the ambulance's parameters exceeded the model's scope. The Collision Deformation Classification (CDC) assigned for the Event 1 damage pattern was 11LDAW2.

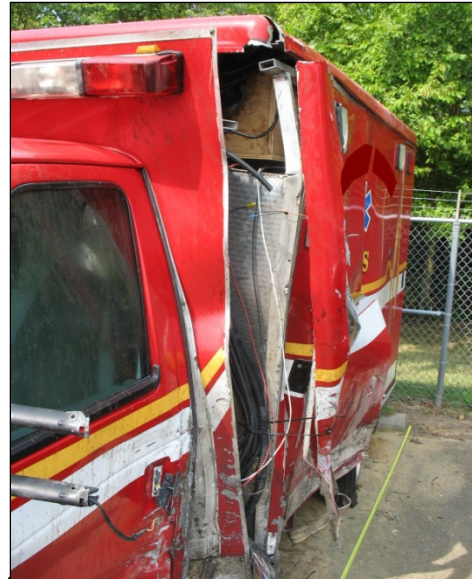
Associated with the Event 1 impact and engagement was the separation of the patient compartment module's frame structure at the left front corner. This included the vertical corner beam, left roof side rail, and frontal roof header (**Figure 9**). The forward two compartments of the module's left plane were jammed shut as a result of the Event 1 impact damage; however, the rear compartment remained closed and operational. No damage or deformation was sustained by the diesel fuel filler nozzle located forward of the left rear axle or the 125 volt / 20 ampere shoreline electrical connection port located aft of the forward compartment door. Also within the damage pattern was buckling to the entire left plane of the patient compartment module, as well as distributed surface abrasions. The left side mirror had been fractured from its stalk and was not with the vehicle.

Figure 9: Separation of the roof structure, left roof side rail, and left front corner support of the module's frame.

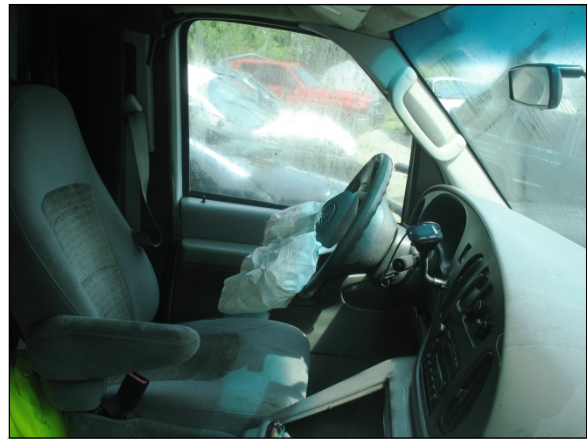
Figure 10: Interior of the Ford ambulance's cab.

consisted of the displacement of the switch panel cover within the center console. All vehicle glazing remained intact and was not damaged during the crash sequence or by occupant contact. **Figure 10** depicts the Ford's cab as viewed through the right front glazing.

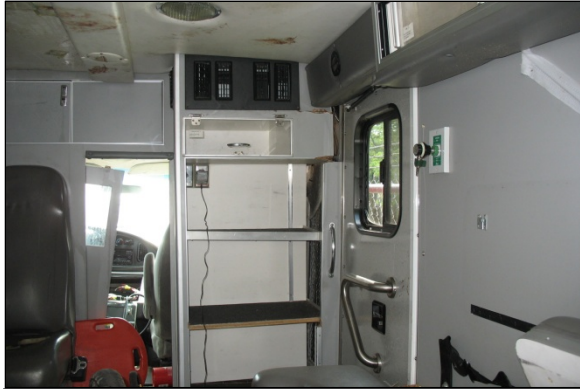
Figure 11: Cabinetry separation within the Ford ambulance's patient compartment.

Cabinetry separation occurred at the left and right aspects of the bulkhead, the result of induced buckling associated with the frontal Event 1 impact and subsequent Event 3 rollover sequence which separated the patient compartment's frame structure. Maximum separation appeared to not exceed 4 cm (1.5 in), and was not of significant magnitude to result in any integrity loss to the patient compartment. Cabinetry separation at the right aspect of the bulkhead, adjacent to the HVAC system, is depicted in **Figure 11**.

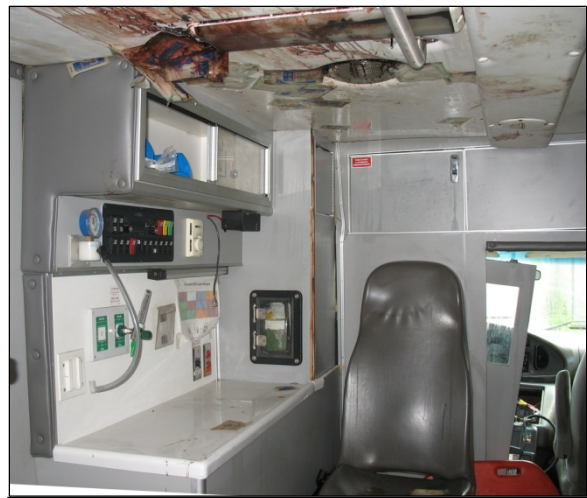
Contact evidence was identified within the patient compartment was attributable to EMS crewmember and patient occupant interaction with interior components. An area of loading and impression on the upper aspect of the captain's chair seat back was attributable to contact and loading from the stretcher occupant during the longitudinal Event 1 impact. There was also contact to surrounding components, including the bulkhead wall and adjacent cabinetry. The crewmember contacted the tubular handrail attached to the end of the bench seat, adjacent to the right side occupant access door. This contact separated the handrail from its mount. Lastly, a large pool of blood, attributed to the stretcher occupant, was located on the ceiling of the patient compartment. Contact evidence identified is depicted in **Figure 12**.

Figure 12: Contact evidence to the captain's chair seat back, interior surfaces, left side cabinetry, and ceiling of the Ford ambulance's patient compartment.

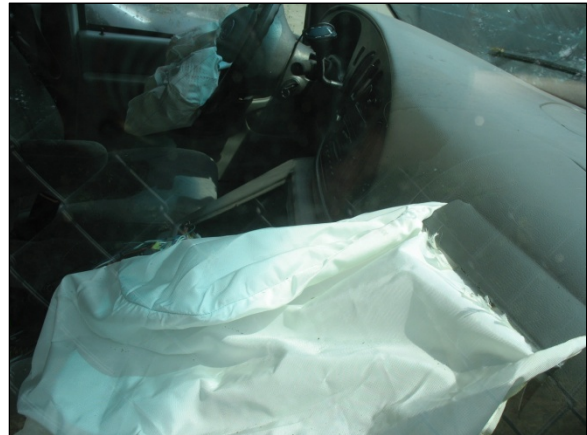
Figure 13: Deployed frontal air bags within the Ford ambulance's cab.

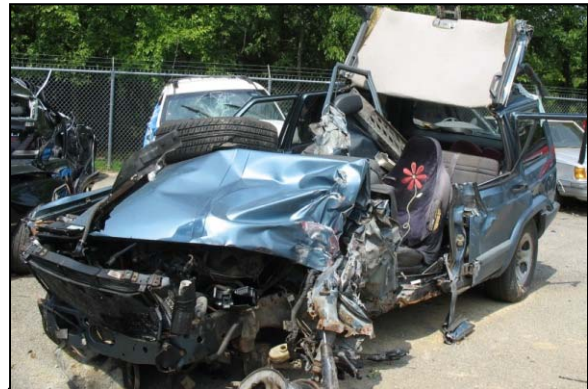
Figure 15: Left front oblique view of the 1999 Jeep.

The front and left planes of the Jeep sustained moderate to severe damage as a result of the crash. An impression from the left corner of the ambulance's patient compartment was visible on the far left aspect of the Jeep's hood. The left front axle of the Jeep was nearly separated from the vehicle, indicative of severe engagement with the left front axle of the Ford ambulance. Direct damage extended down the left plane of the Jeep to the left rear door. Based on the images of the Jeep, the CDC assigned to the Event 1 damage pattern was 12FLEE9.
